**DRAFT REPORT
ROUND 10 DAM ASSESSMENT - MAY 18, 2011
PPL GENERATION, LLC.
BRUNNER ISLAND POWER STATION
ASH BASIN NO. 6 WITH POLISHING POND, EQUALIZATION POND AND
INCIDENTAL WASTE TREATMENT BASIN (IWTB)
YORK HAVEN, PENNSYLVANIA**

**GZA GeoEnvironmental, Inc.
One Edgewater Drive
Norwood, Ma 02062
GZA File No. 01.0170142.30**

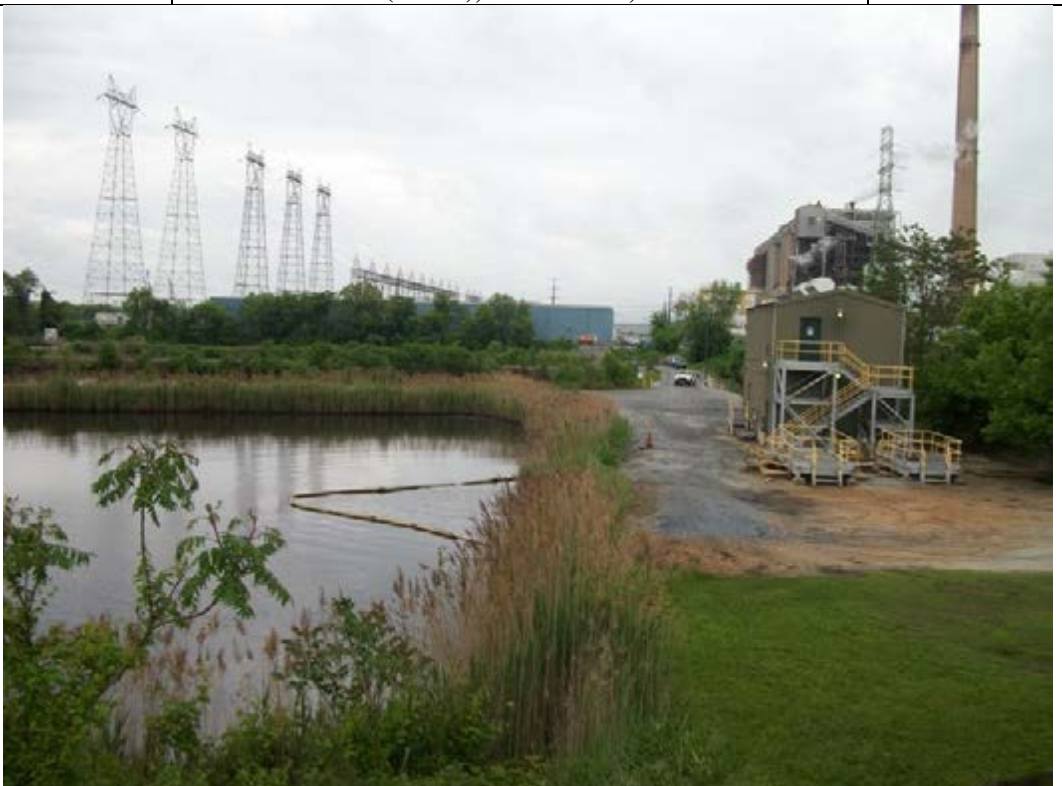
Client Name: U.S. Environmental Protection Agency		Site Location: PPL Brunner Island Station Incidental Waste Treatment Basin (IWTB), York Haven, PA	Project No. 170142.30
Photo No. 65	Date: 5/18/2011

Direction Photo Taken: Southerly			
Description: View of north lagoon and the Coal Pile Runoff Treatment Facility.			
Photo No. 66	Date: 5/18/2011

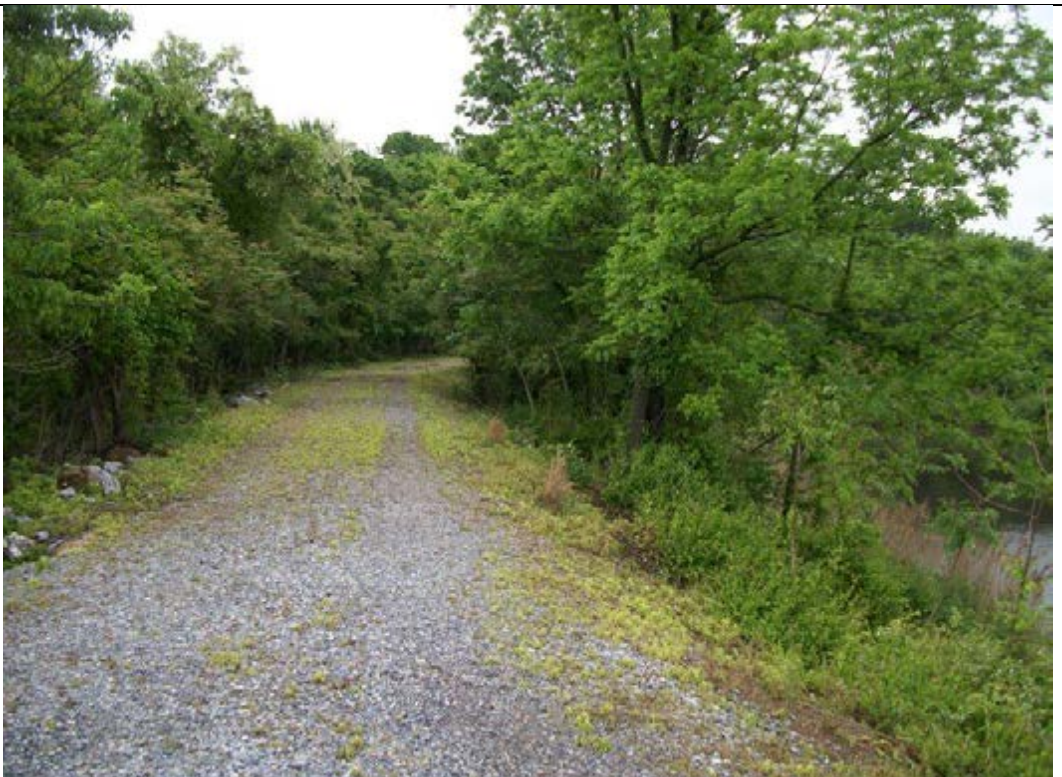
Direction Photo Taken: Northeasterly			
Description: View of the crest along the Susquehanna Flood Control Levee which forms the north embankment of the north lagoon and the east embankment of the north, middle and south lagoons. North lagoon is at right.

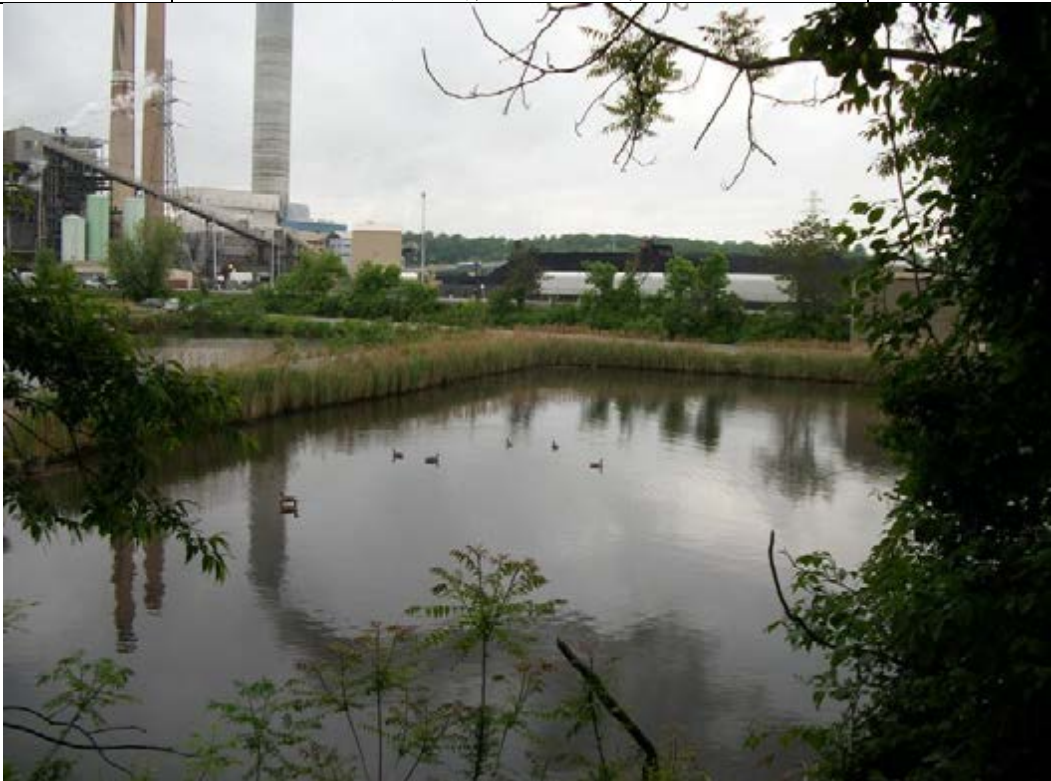
Client Name: U.S. Environmental Protection Agency		Site Location: PPL Brunner Island Station Incidental Waste Treatment Basin (IWTB), York Haven, PA	Project No. 170142.30
Photo No. 67	Date: 5/18/2011

Direction Photo Taken: Southerly			
Description: Overview of north lagoon as viewed from the crest of the Susquehanna Flood Control Levee. Note middle pond is at left.

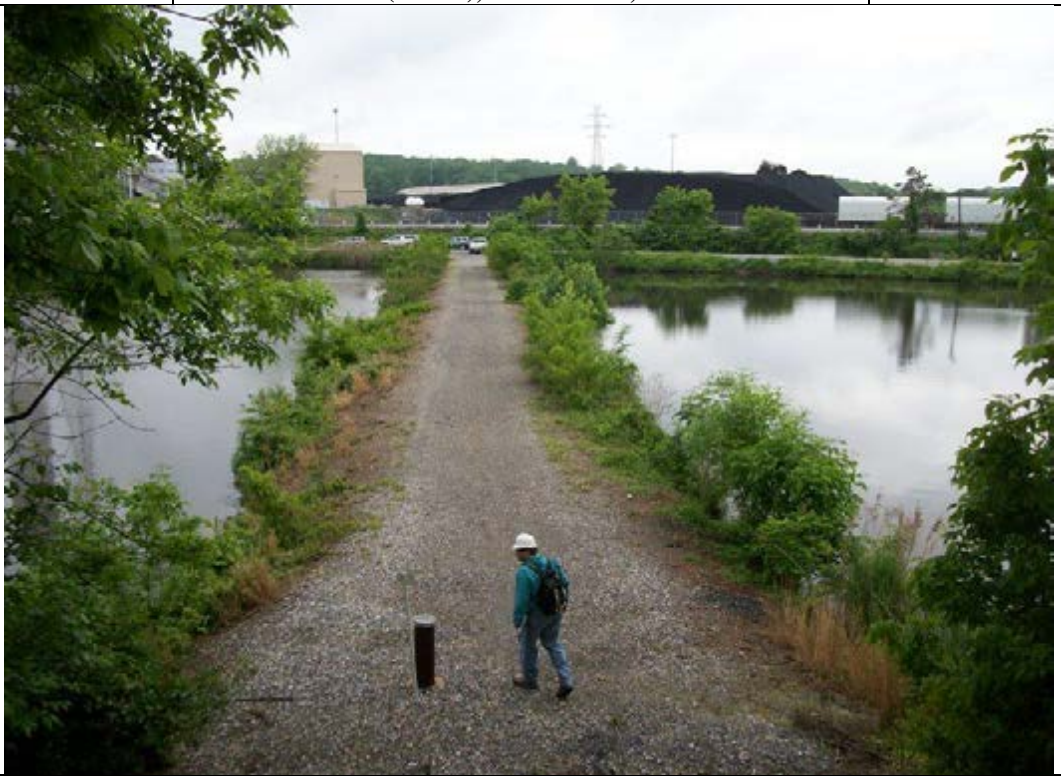
Client Name: U.S. Environmental Protection Agency		Site Location: PPL Brunner Island Station Incidental Waste Treatment Basin (IWTB), York Haven, PA	Project No. 170142.30
Photo No. 69	Date: 5/18/2011

Direction Photo Taken: Southwesterly			
Description: Overview of common dike between the south and middle lagoons from the crest of the Susquehanna Flood Control Levee. Note the ground water quality testing well in the foreground.			
Photo No. 70	Date: 5/18/2011

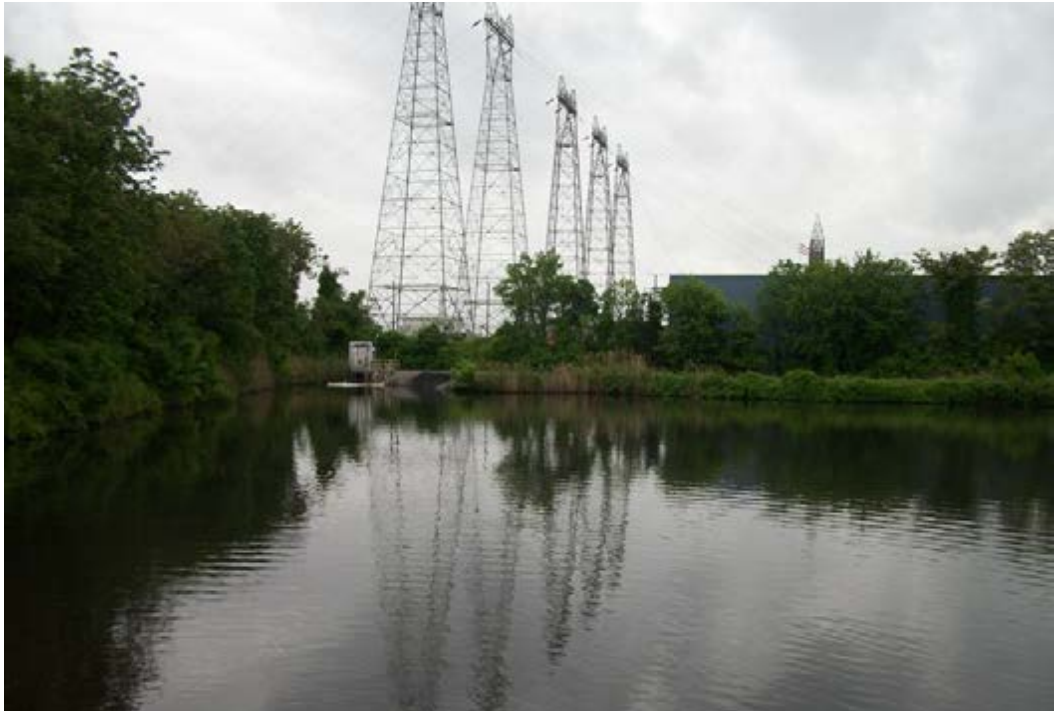
Direction Photo Taken: Southeasterly			
Description: View of south lagoon from common dike between the south and middle lagoons. Note Decant Gate and Sensor Monitoring Structure at left side.
